Acton Quarry

4th Line Seeps Update – June 16, 2015

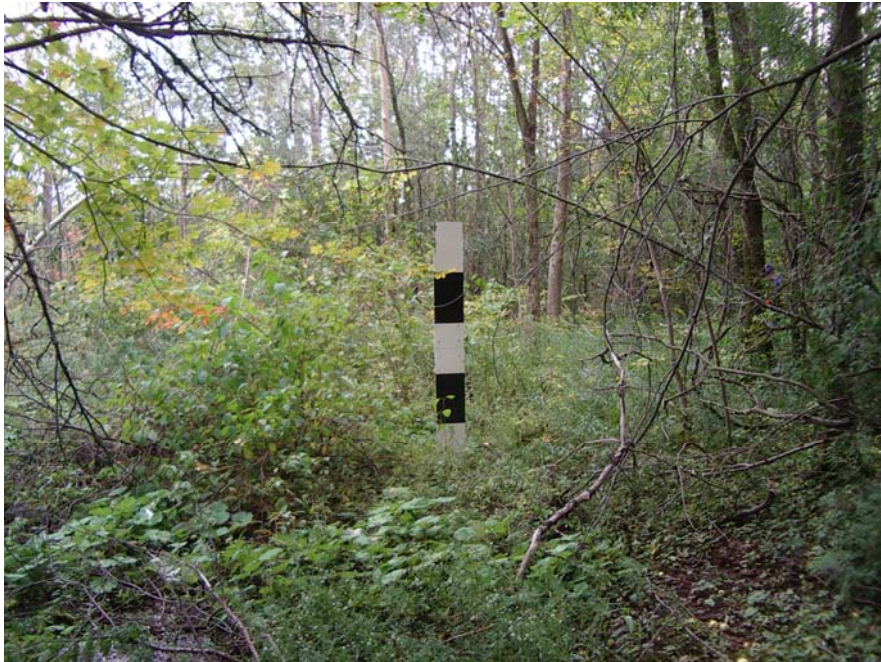
S5: September 22, 2013

- Annual vegetation monitoring occurs at plots located in Seeps S1, S5 and S6b.
- Few changes in wetland plots from 2009 until the summer of 2013, when some cedars came down in a wind storm.
- The December 2013 ice storm also resulted in a number of trees and tree limbs falling into the plot locations.
- 2014 Seeps Report recommends clearing fallen woody vegetation that is covering/shading wet meadow vegetation and/or relocating vegetation monitoring plots to areas not affected by fallen trees, as necessary.

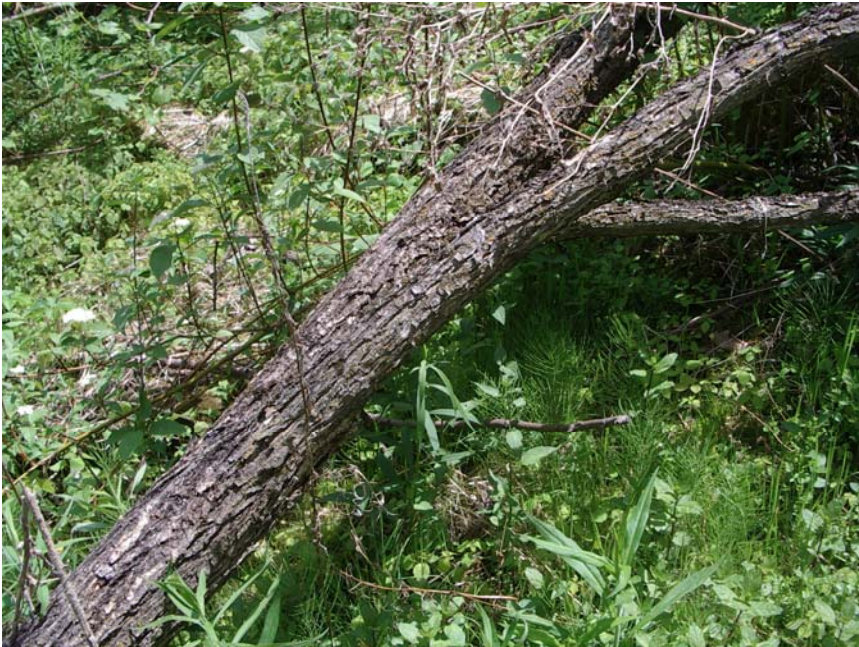
- Some local citizens have recently raised concerns about tree dieback and tree mortality near the seeps, in proximity to the Bruce Trail.
- Most dieback and mortality appears to be related to plant diseases, e.g. Butternut Canker and Dutch Elm Disease, insect pests and storm damage. This is not related to the operation of seep mitigation system.

May 26, 2015.
Downed White Elm limbs.

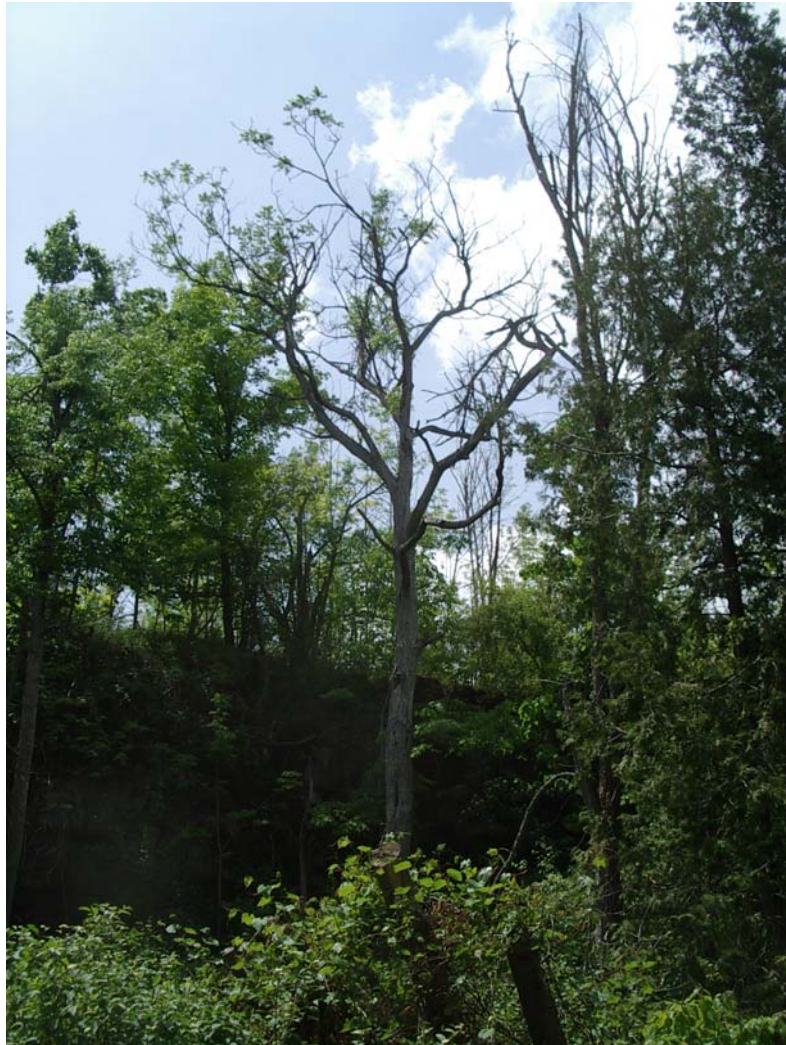
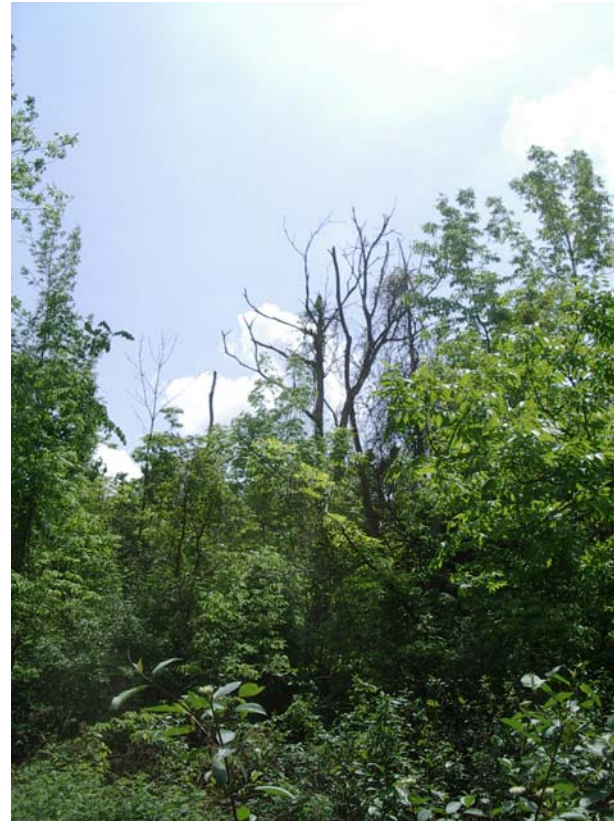
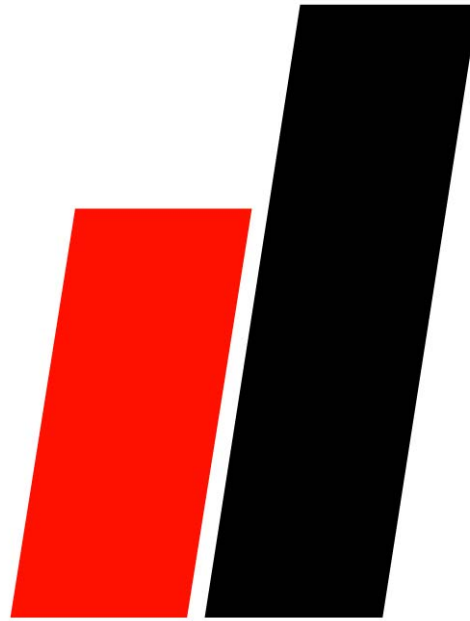
May 26, 2015.
Declining and dead Butternut trees.
